Re: Variance Request – Eaton Sugar Beat Factory (Work Area 3A), CO Section III.W.

Regulation No. 8, Part B Variance Request Form

Subject: **Eaton Sugar Beet Factory, Structural Recommendations No. 2**

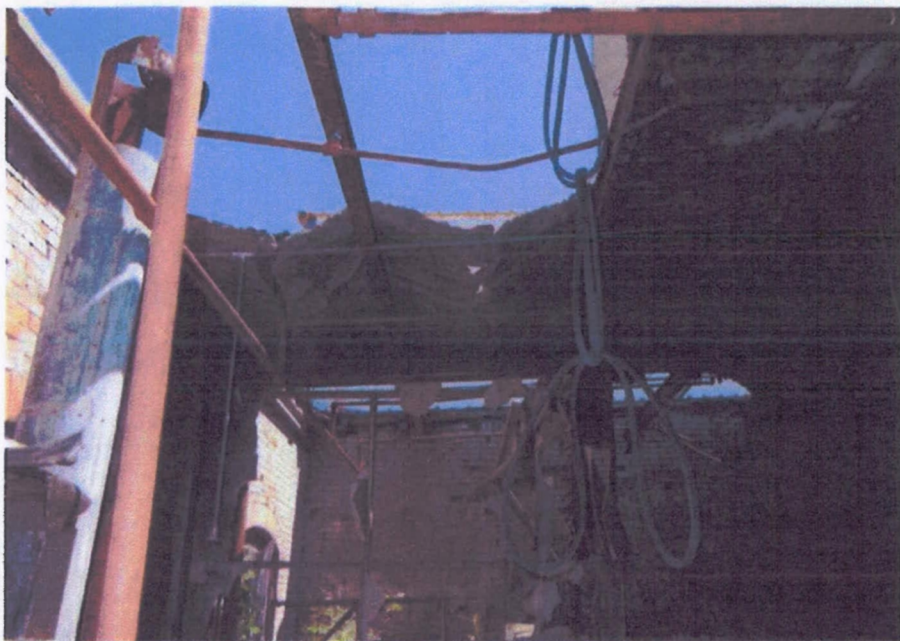
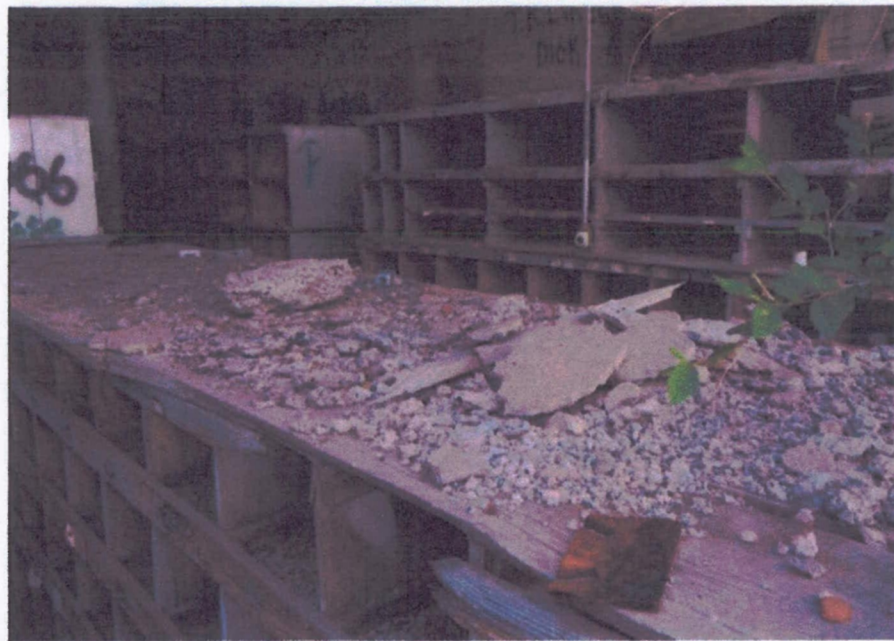
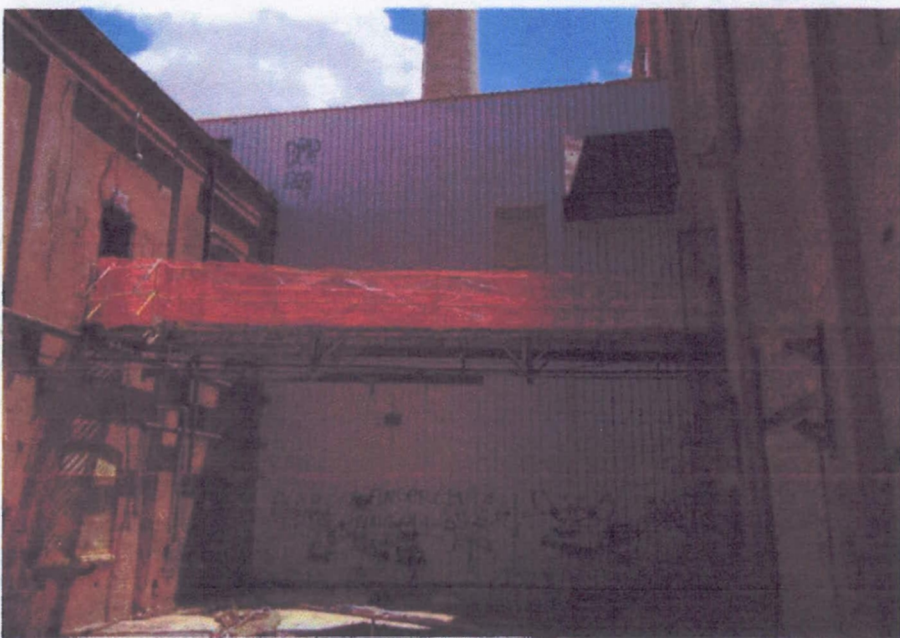
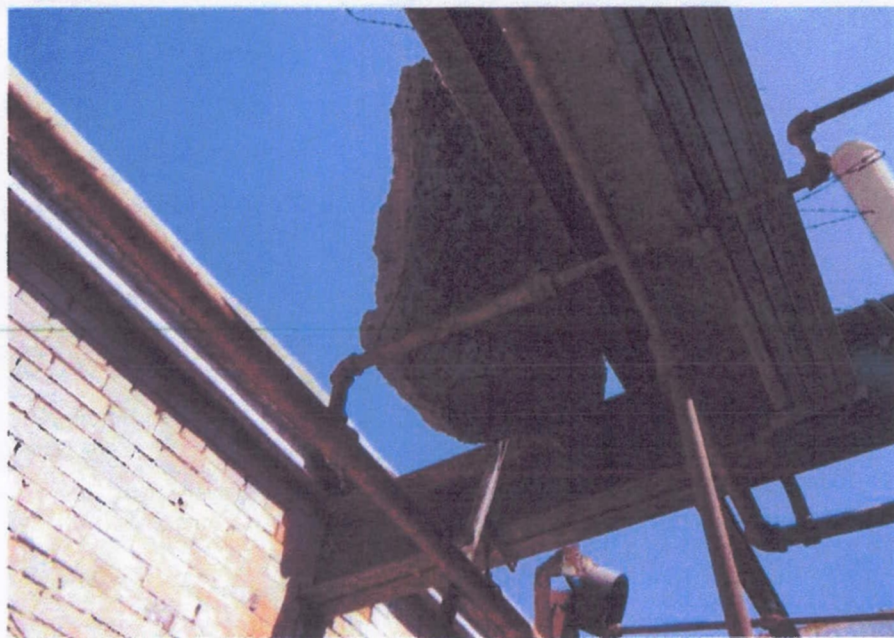
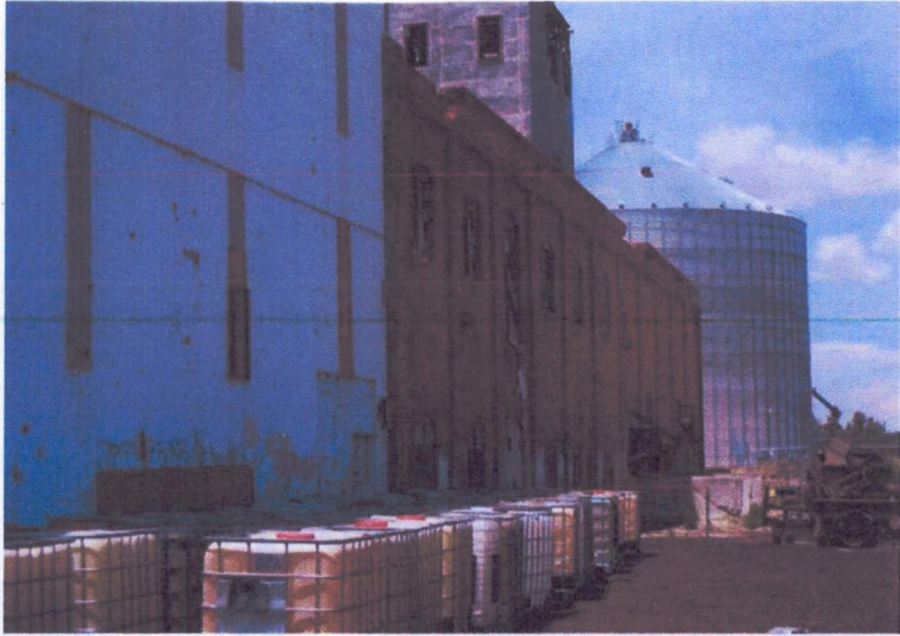
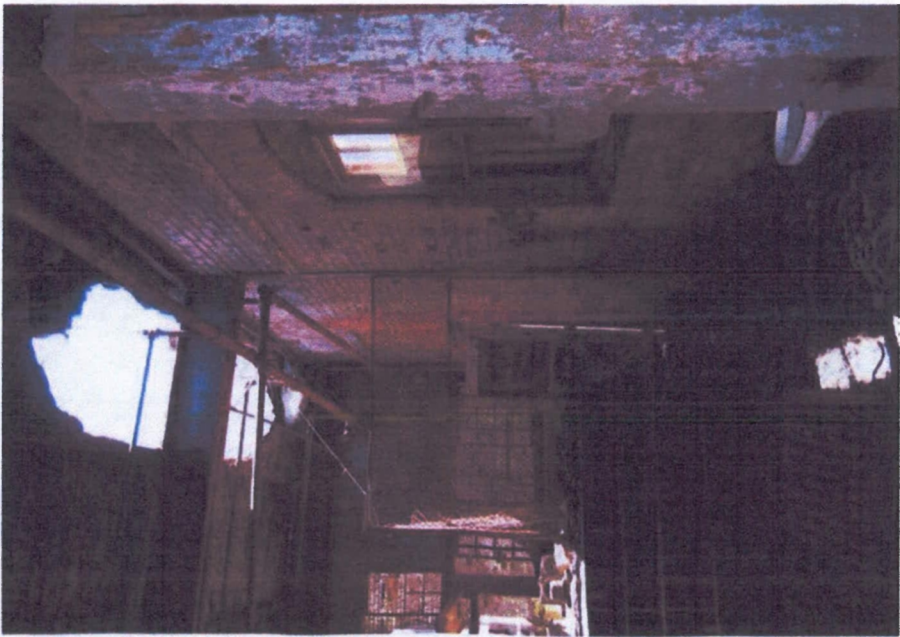
The deterioration observed throughout the floors of the Main Mill Building typically consisted of deteriorated concrete and exposed, corroded steel wire reinforcing. This deterioration is likely due to continued exposure to moisture which corroded the steel and damaged/delaminated the concrete cover on the underside of the slabs. This type of deterioration has an impact on the slabs structural capacity, specifically with regard to resisting punching shear from large point loads applied over a small area. Evidence of this can be seen in the photographs below and is the main reason it is not recommended to use the electric pallet jack on these floors.

Zone 3a, adjacent to Zone 2, was observed due to concern about the roof structure and its supporting masonry wall. The wall in question is at the south end of Zone 3a, and abuts the metal building framing of Zone 2. As shown in the photograph below, this load bearing wall is supporting the steel beams which support the concrete roof deck.

Do not use motorized electric pallet jack on floors with exposed reinforcing. Floor areas with exposed wire reinforcing, or those suspected of having corroded reinforcing, should be accessed with caution and if concentrated point loads in excess of foot traffic are expected, supplemental measure should be taken. These measures need to provide some level of "redundancy" or "support" to keep something from creating or falling through a hole in the concrete slabs and could consist of sheets of plywood or expanded wire mesh panels spanning over the steel support beams below.
